# APISAT 2019

**2019 ASIA PACIFIC  
INTERNATIONAL SYMPOSIUM  
ON AEROSPACE TECHNOLOGY**

# **The Research on Aircraft Nose Landing Gear Bay Damage**

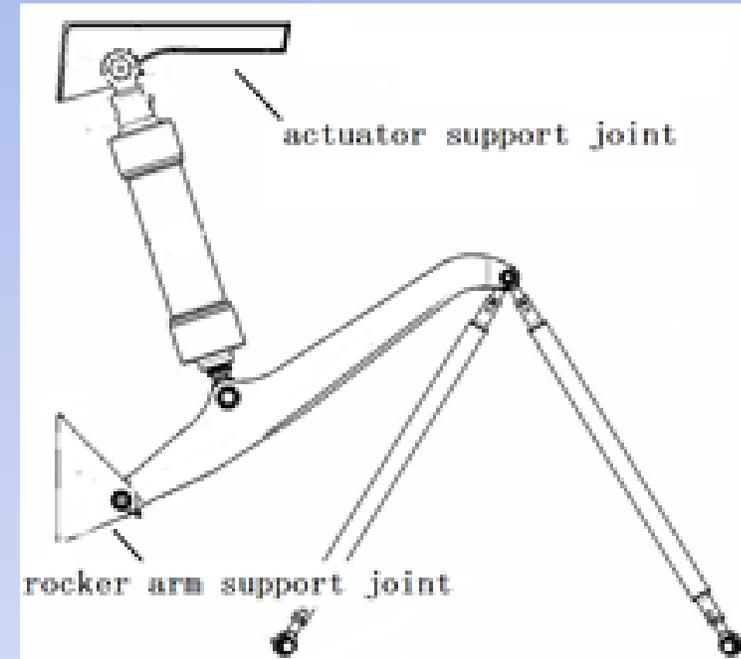
After on-the-spot observation, it was preliminarily decided that the accident resulted from the abnormal movement of the landing gear of the door retraction and extension mechanism, resulting in the tremendous noise.

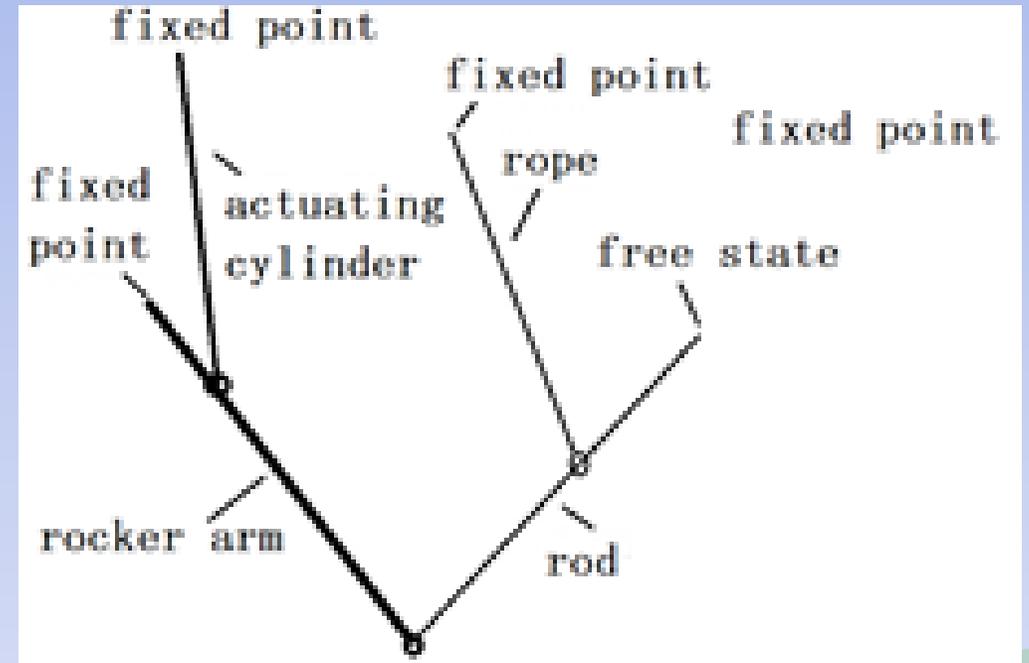
It was confirmed that before the accident occurred, the landing gear door actuator was in the extended state and the door were open. The door and the door tie were not connected, at the same time the two rods were hanged in the air by the rope.

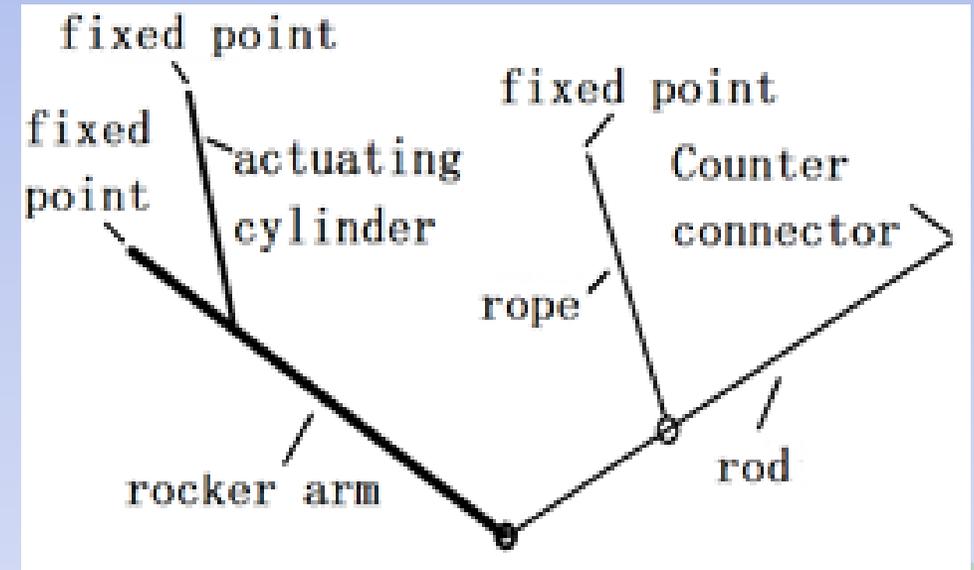
During the system checking, the door actuator were working and began to shrink so that the door rods were moving. In the process of movement the door rods came into contact with the end of joint on the right side. In the end the door rods were unable to move freely. But the door actuator continued to pull on the rocker arm so that the carrying capacity of the structure was exceed, leading to the accident finally.

Through the relevant measurement and observation, the structure was damaged and the landing gear compartment structure bolts were broken, as follows:

- 1)The rocker bearing joint were teared;
- 2)The door rods were distorted;
- 3)The right bearing joint was damaged;
- 4)The connection bolts were fractured.

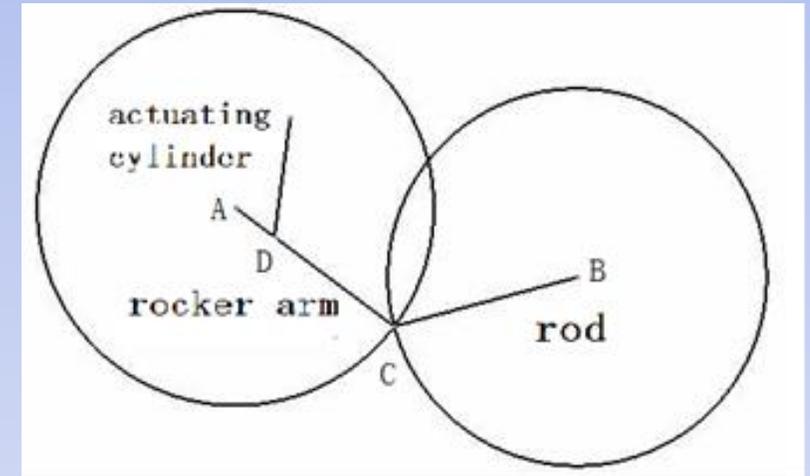
The location of the mechanism was needed to be determined by analysis firstly. It was assumed that the rocker bearing joint was at A, and the right cabin seat joint was at B. The intersection point of the actuating barrel and the rocker arm was D. Because the door rocker and door arm rods were respectively in the left and right arm support top hatch bearing joints. Respectively A and B as the center of the door rocker and the door rod length radius circle, two circles of intersection was at C.

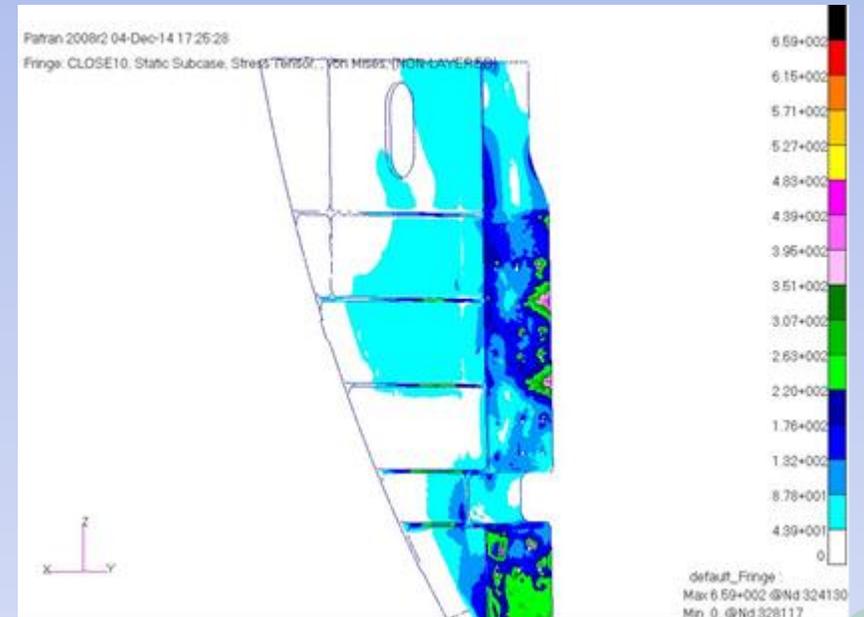
After calculation, figure 5 showed rocker bearing joint Von Mises stress distribution when the cylinder angle was  $10^\circ$ . It can be seen from the figure that the maximum stress on the frame structure had exceeded the allowable stress. It was coincided with destruction site. The schematic diagram of the rocker arm support bolts were shown in Figure 6. The results of the bolts were shown in Table 2 and table 3, and the No.17 of the rocker bearing joint bolt was broken and was in conformity with the damage condition. Thus, the state of the motion of the mechanism can be determined when the structure was damaged.

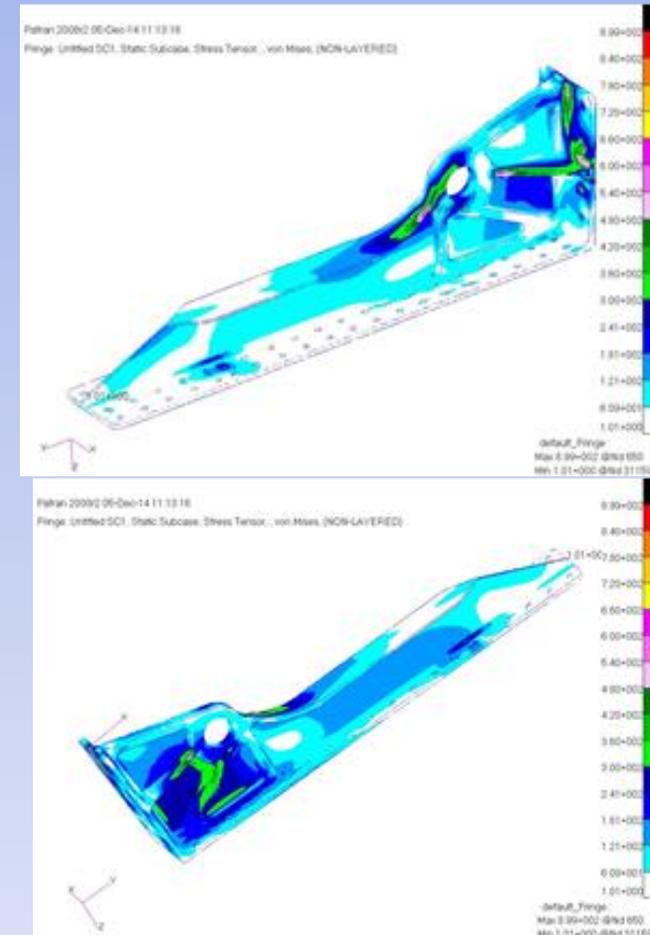
The stress distribution nephogram of the Von Mises of the actuating cylinder support were shown in Figure 8. The actuating cylinder support met the strength requirement from the diagram. The actuating cylinder joint structure was not damaged.
