# APISAT 2019

**2019 ASIA PACIFIC  
INTERNATIONAL SYMPOSIUM  
ON AEROSPACE TECHNOLOGY**

# **The Research on Aircraft Nose Landing Gear Bay Damage**

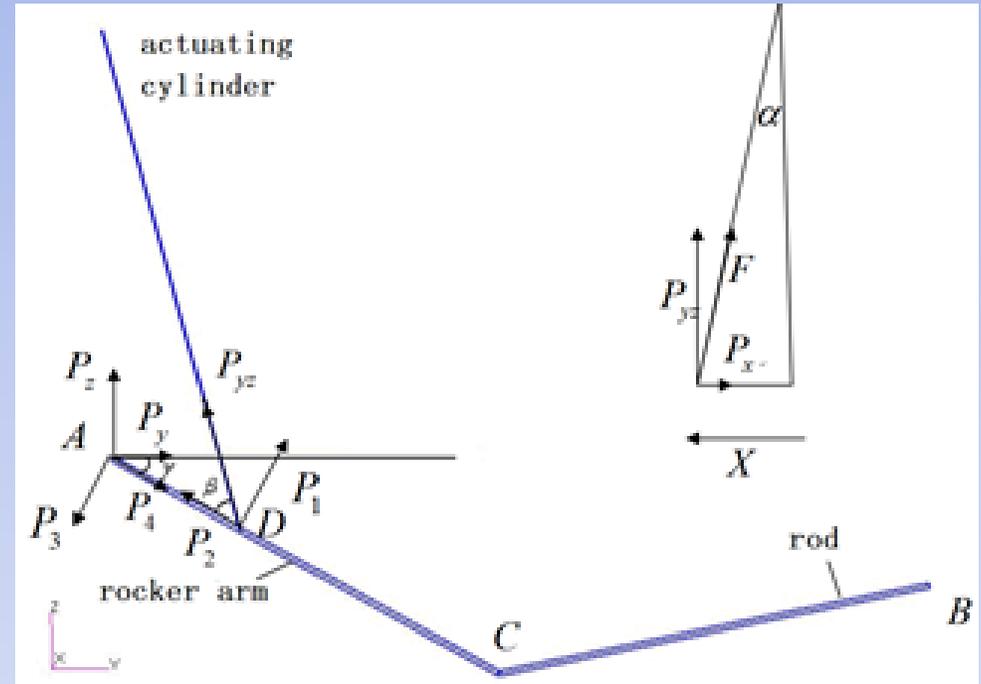
$$P_x = F \sin \alpha \quad P_1 = P_{yz} \sin \beta \quad P_3 = \frac{2}{3} P_1$$

$$P_{yz} = F \cos \alpha \quad P_2 = P_{yz} \cos \beta \quad P_4 = P_2$$

$$P_y = P_3 \sin \gamma - P_4 \cos \gamma$$

$$= \frac{2}{3} F \cos \alpha \sin \beta \sin \gamma - F \cos \alpha \cos \beta \cos \gamma$$

$$P_z = P_3 \cos \gamma + P_4 \sin \gamma$$

$$= \frac{2}{3} F \cos \alpha \sin \beta \cos \gamma + F \cos \alpha \cos \beta \sin \gamma$$
